The Clay Research Group

January 2011

CONTENTS

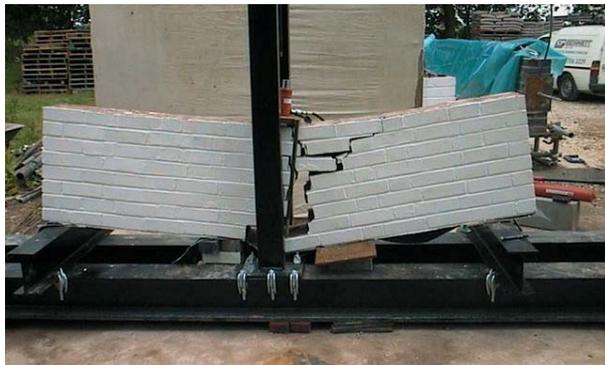
Several years ago MatLab researched the effect of post-tensioning on masonry panels. They induced flexure using the arrangement shown below, imposing a point load at the centre of a 2.2m long panel supported at either end and with temporary propping along its length.

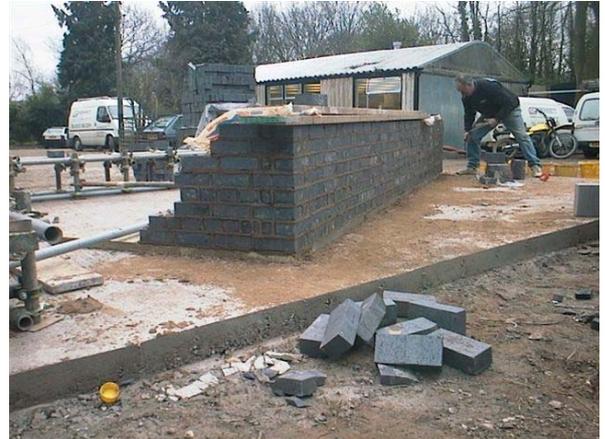
A variety of panels were built, and a range of materials used. Above we have one of the corner panels in engineering brickwork.

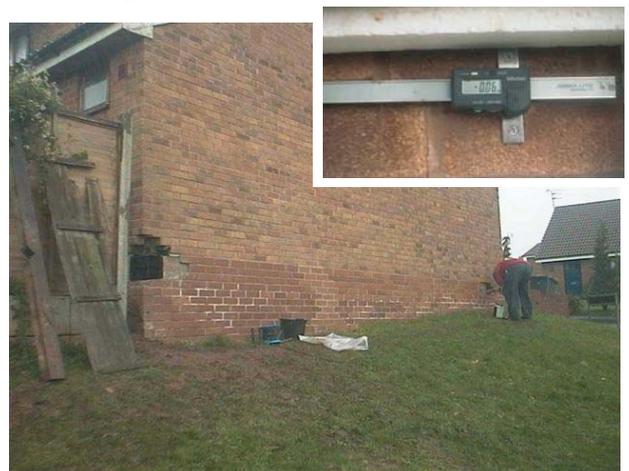
Below, the method was applied to a long gable wall built off a deep footing on the Mercia Mudstone with a P.I. of around 25%.

The treatment resolved the (minor) problem of root induced clay shrinkage as far as we are aware and the gauge reveals crack closure on tensioning.

A possible use assuming the problem of openings and H&S issues can be overcome might be low level damage of an irritating nature where the tree cannot be removed and recurrent cracking is likely.
